Safety Edge in NC

Road Map

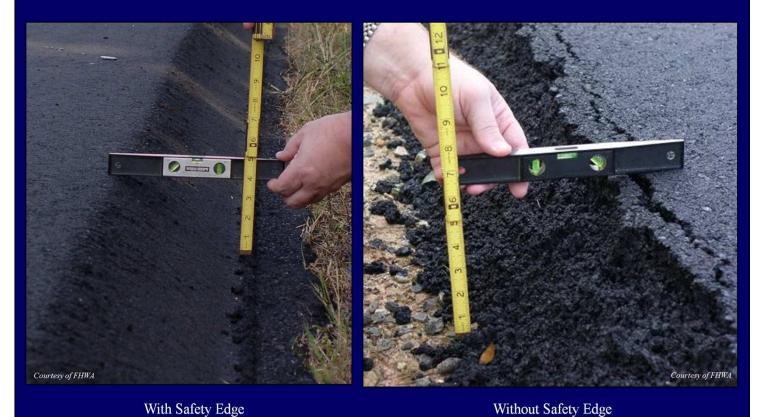
Safety Edge versus "NO" Safety Edge

This slide demonstrates the 30 degree shaped and formed pavement edge created by using a safety edge device VERSUS the standard pavement edge that is approximately 45-60 degrees with a non-shaped and non-formed pavement edge that crumbles and breaks off leaving a potential 90 degree pavement edge. Photos above are from a Georgia Safety Edge Implementation.

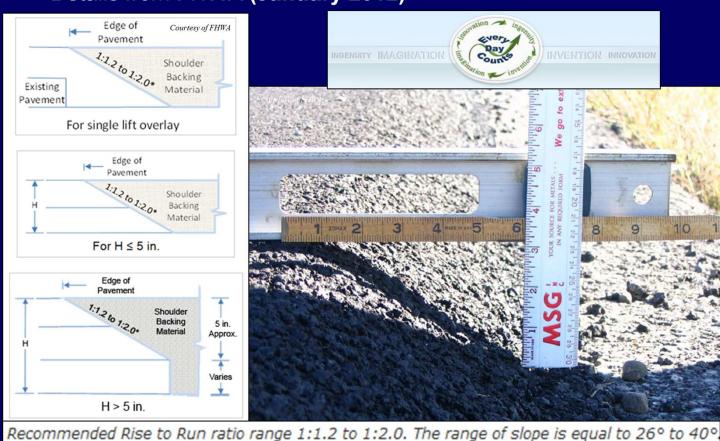
Details from FHWA (January 2012)

The safety edge forms a 30 degree slope during the paving process instead of a 45 to 90 degree slope that standard paving practices currently construct. Photos above are from a Georgia Safety Edge Implementation.

FHWA January 2012 Specifications state that the finished edge should be between 26 degrees and 40 degrees.

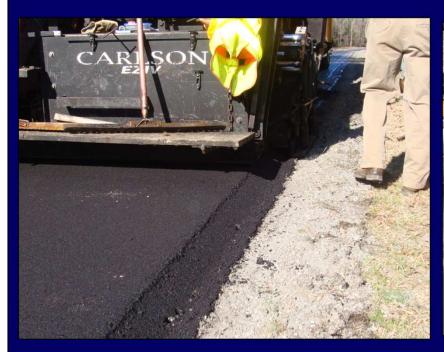
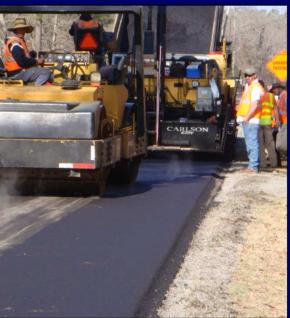
Hot Mix Installation – SR 1355

These photos are from the first ½ mile of implementation.

Photos from March 17, 2011. Map 6 – SR 1355 (1.58 miles). 1.5" Lift, Hot Mix. Shoe – NCDOT Prototype 1.

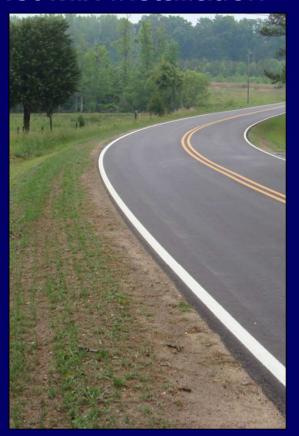
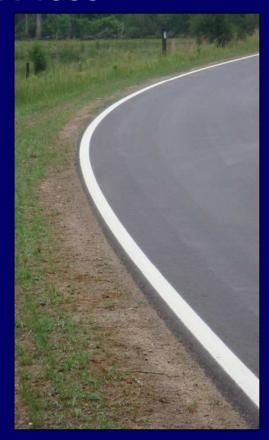
Hot Mix Installation – SR 1355

Same curve as shown in previous slide. This photo demonstrates how the shoulder material should be pulled flush to the new pavement surface.

Map 6 – SR 1355 (1.58 miles). 1.5" Lift, Hot Mix. Shoe – NCDOT Prototype 1. Photos from May 11, 2011.

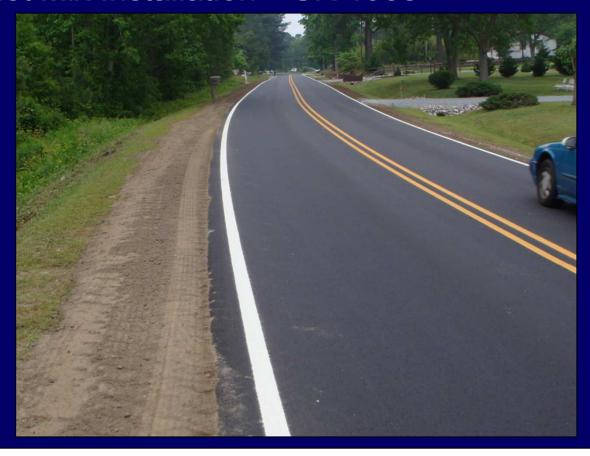
Hot Mix Installation – SR 1938

This photo demonstrates how the shoulder material should be pulled flush to the new pavement surface.

Photo from May 11, 2011. Map 1 – SR 1938 (1.89 miles). 1.5" Lift, Hot Mix. Shoe – Carlson End Gate.

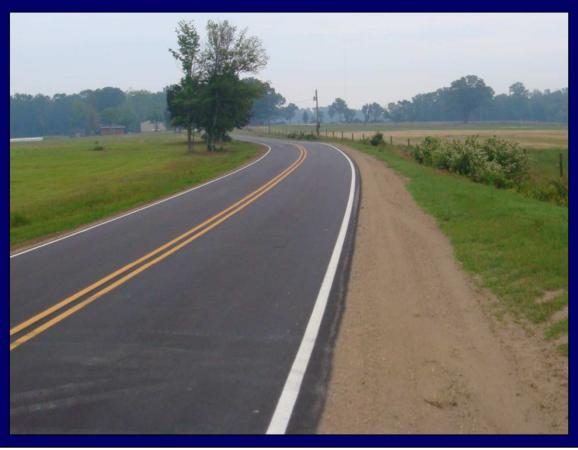
Warm Mix Installation – SR 1007

This photo demonstrates how the shoulder material should be pulled flush to the new pavement surface.

Photo from May 11, 2011. Map 4 – SR 1007 (2.10 miles). 1.5" Lift, Warm Mix. Shoe – NCDOT Prototype 2.

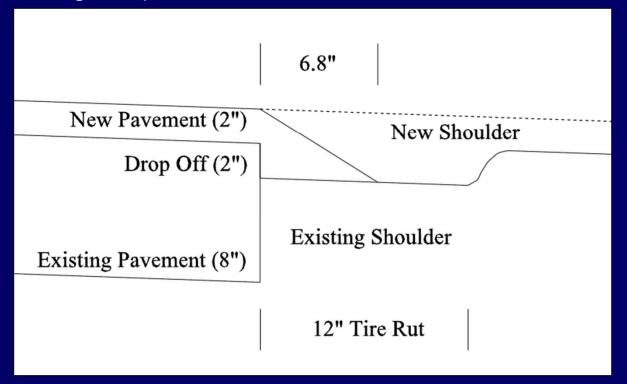
- Cross Section 2 Cross-Sectional Width Remains the Same
- 2" Edge Drop Off with a 12" Tire Rut

This slide represents what would occur if there was an existing 2 inch edge drop-off. The edge would extend out an additional 3.4 inches on a 2 inch lift (distance is increase from 3.4 inch increase when there is no edge drop off). Keep in mind that the edge devices make a safety edge shape that is 6 to 9 inches wide (dependent on device). For this example of a 6.8 inch safety edge shape (from a 2 inch edge drop-off), the 6 inch safety edge device would only make the shape for the first 6 inches after the edge breakpoint, then the asphalt would fall off as usual. This will be demonstrated in multiple photos throughout this section.

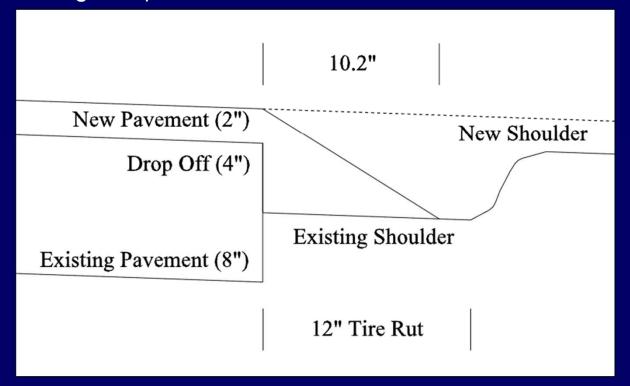
- Cross Section 2 Cross-Sectional Width Remains the Same
- 4" Edge Drop Off with a 12" Tire Rut

This slide represents what would occur if there was an existing 4 inch edge drop-off. The edge would extend out an additional 6.8 inches on a 2 inch lift (distance is increase from 3.4 inch increase when there is no edge drop off). Keep in mind that the edge devices make a safety edge shape that is 6 to 9 inches wide (dependent on device). For this example of a 10.2 inch safety edge shape (from a 4 inch edge drop-off), the 9 inch safety edge device would only make the shape for the first 9 inches after the edge breakpoint, then the asphalt would fall off as usual. This will be demonstrated in multiple photos throughout this section.

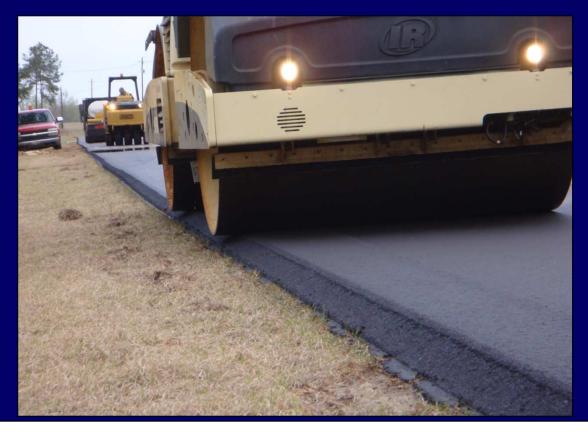
Hot Mix Installation – SR 1354

Notice the roller is hanging over the safety edge and the edge is not deforming/losing its angle.

Photos from March 21, 2011. Map 5 – SR 1354 (1.61 miles). 1.5" Lift, Hot Mix. Shoe – NCDOT Prototype 1.

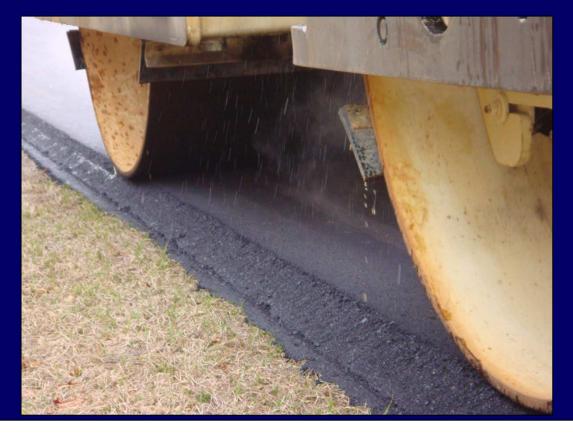
Hot Mix Installation – SR 1354

Notice the roller is hanging over the safety edge and the edge is not deforming/losing its angle.

Photos from March 21, 2011. Map 5 – SR 1354 (1.61 miles). 1.5" Lift, Hot Mix. Shoe – NCDOT Prototype 1.

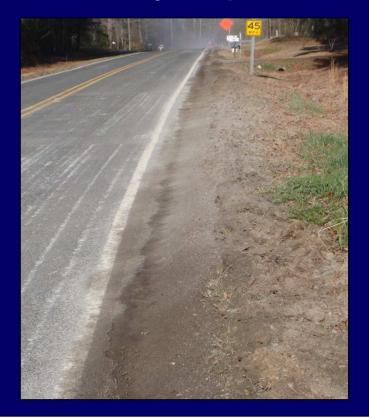
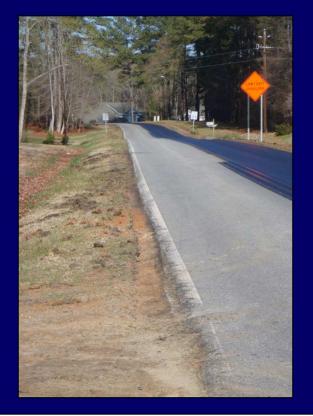
Shoulders Should Be Clipped Before

The photos above demonstrate clipping of the shoulders prior to resurfacing.

Photos from March 17, 2011. Map 6 – SR 1355 (1.58 miles). 1.5" Lift, Hot Mix. Shoe – NCDOT Prototype 1.

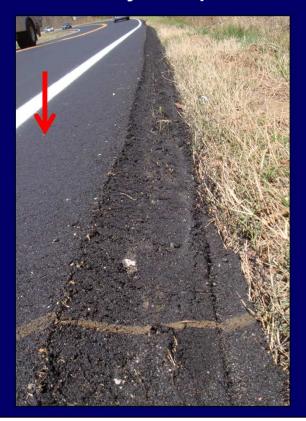
Shoulders Should Be Clipped Before

The photos above demonstrate when clipping of the shoulders IS NOT completed prior to resurfacing and the asphalt breakpoint is placed far right of the existing edge of pavement. The asphalt breakpoint in this photo was approximately 12" to 16" to the right of the existing edge of pavement. The approximate location of the existing edge of pavement is highlighted in the photo on the right with a red arrow.

This occurred on approximately 200' of approximately 10 miles observed.

Photos from March 29, 2011. Map 2 – SR 1921 (0.64 miles). 1.5" Lift, Warm Mix. Shoe – NCDOT Prototype 1.

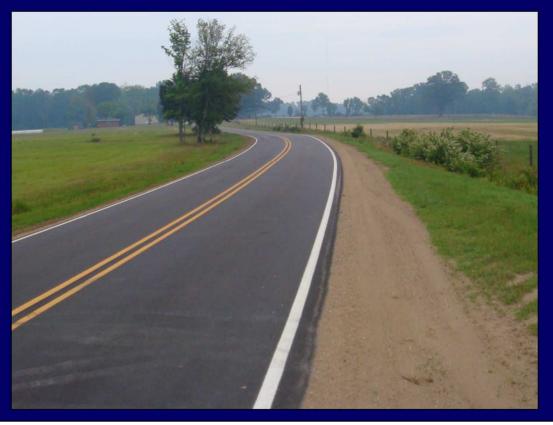
Warm Mix Installation – SR 1007

This photo demonstrates how the shoulder material should be pulled flush to the new pavement surface.

Photo from May 11, 2011. Map 4 – SR 1007 (2.10 miles). 1.5" Lift, Warm Mix. Shoe – NCDOT Prototype 2.

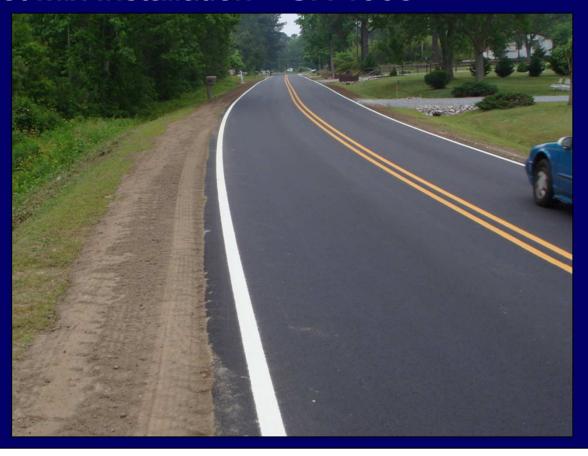
Hot Mix Installation – SR 1938

This photo demonstrates how the shoulder material should be pulled flush to the new pavement surface.

Photo from May 11, 2011. Map 1 – SR 1938 (1.89 miles). 1.5" Lift, Hot Mix. Shoe – Carlson End Gate.

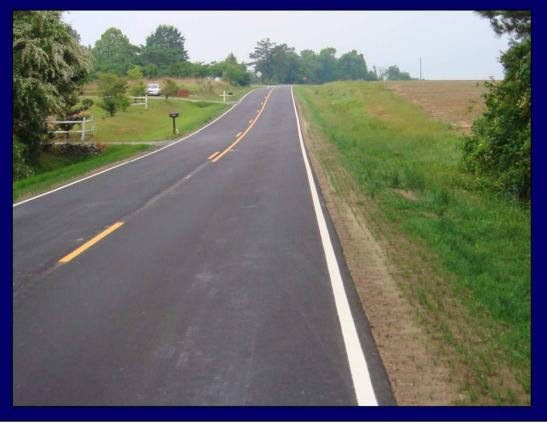
Warm Mix Installation – SR 1327

This photo demonstrates how the shoulder material should be pulled flush to the new pavement surface.

Photo from May 11, 2011. Map 3 – SR 1327 (0.94 miles). 1.5" Lift, Warm Mix. Shoe – NCDOT Prototype 1.

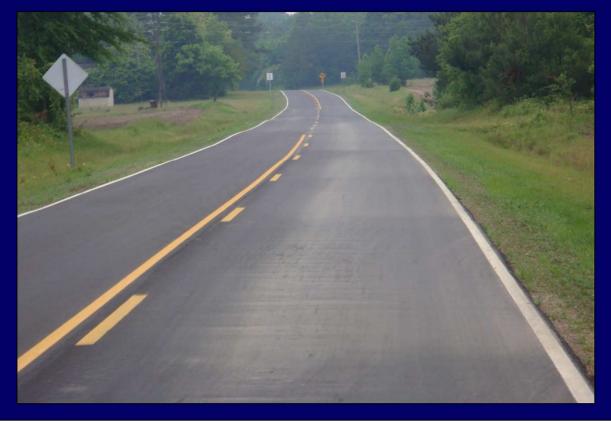
Hot Mix Installation – SR 1354

This photo demonstrates how the shoulder material should be pulled flush to the new pavement surface.

Photo from May 11, 2011. Map 5 – SR 1354 (1.61 miles). 1.5" Lift, Hot Mix. Shoe – NCDOT Prototype 1.

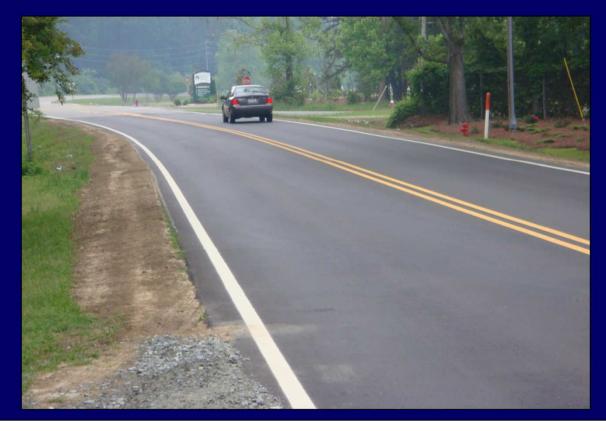
Warm Mix Installation – SR 1921

This photo demonstrates how the shoulder material should be pulled flush to the new pavement surface.

Photo from May 11, 2011. Map 2-SR 1921 (0.64 miles). 1.5" Lift, Warm Mix. Shoe – NCDOT Prototype 1.

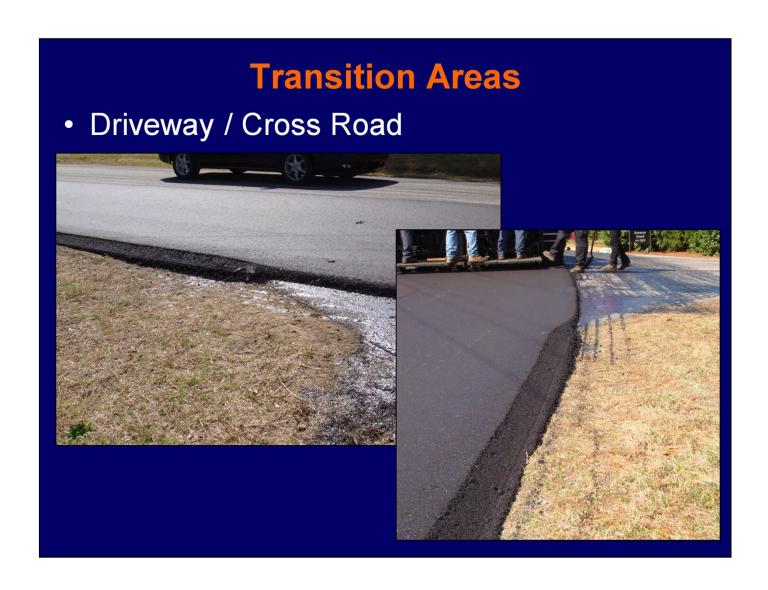
Using the electric drill to raise and lower the device allows for a smooth driveway / cross road transition.

Photos from March 29, 2011. Map 8-SR 1345 (0.75 miles). 1.5" Lift, Warm Mix. Shoe – NCDOT Prototype 2.

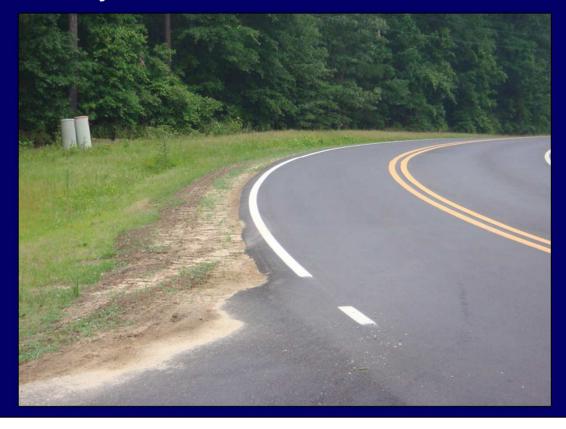
Driveway / Cross Road

Using the electric drill to raise and lower the device allows for a smooth driveway / cross road transition.

Photo from May 11, 2011. Map 8-SR 1345 (0.75 miles). 1.5" Lift, Warm Mix. Shoe – NCDOT Prototype 2.

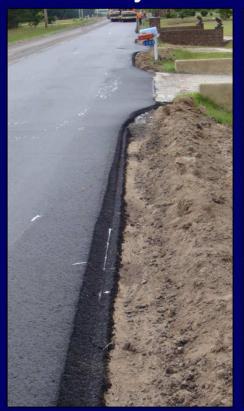
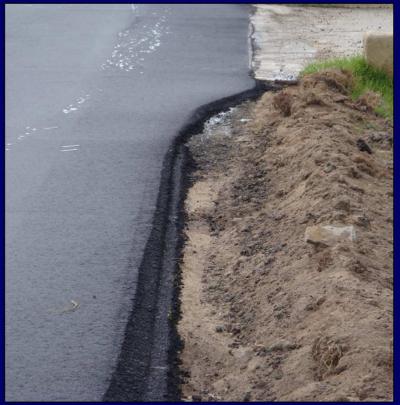
Driveway / Cross Road

Using the electric drill to raise and lower the device allows for a smooth driveway / cross road transition. At a concrete driveway.

Photo from July 19, 2011. Robeson County – SR 1339 (10.20 miles). 1.25" Lift, Hot Mix. Shoe – NCDOT Prototype 2.

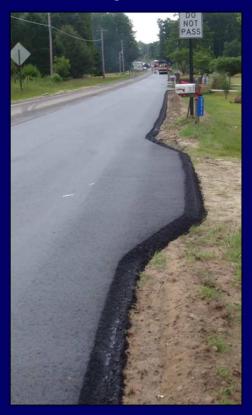
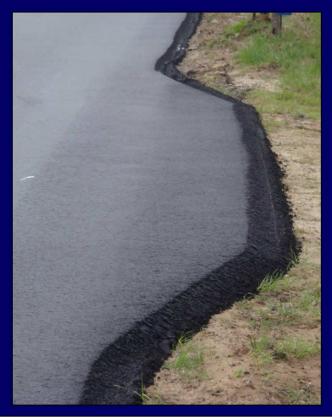
Driveway / Cross Road

Using the electric drill to raise and lower the device allows for a smooth driveway / cross road transition. At a gravel driveway.

Photo from July 19, 2011. Robeson County – SR 1339 (10.20 miles). 1.25" Lift, Hot Mix. Shoe – NCDOT Prototype 2.

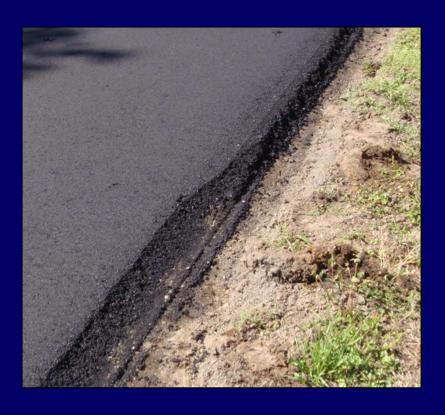
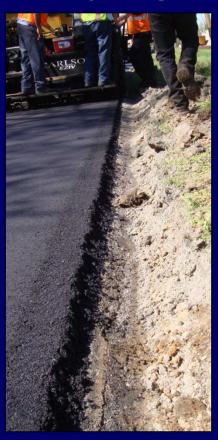
Safety Edge versus No Safety Edge

FHWA visited a few of the Pilot Project sites and needed to take sample densities with and without the safety edge device in play. The photos above demonstrate the edge of pavement with and without safety edge. The safety edge was raised for approximately 1000 feet for the density test sections. We have not yet received the results of this testing. The next two slides represent the same.

Photos from April 6, 2011. Map 4 – SR 1007 (2.10 miles). 1.5" Lift, Warm Mix. Shoe – NCDOT Prototype 2.

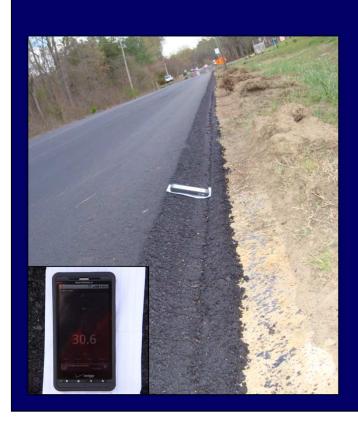
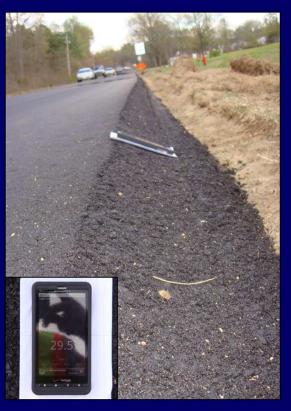
Angle of Finished Edge

The photos above demonstrate final 30 degree angle we have been seeing on the Pilot Project sites. We have seen angles as low as 26 degrees. Notice the final angle taken with Droid X Angle Finder App.

Photos from March 24, 2011. Map 2-SR 1921 (0.64 miles). 1.5" Lift, Warm Mix. Shoe – NCDOT Prototype 1.

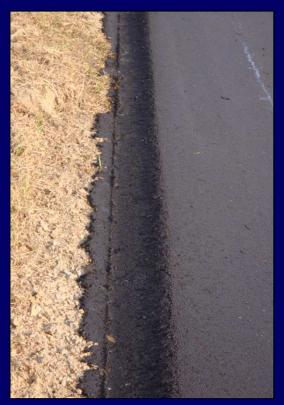
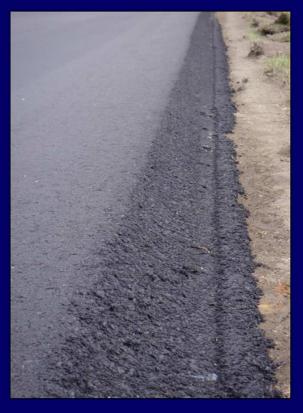
Edge Rollover – Edge Flattening

The photos above show the difference that may be seen between final angles on hot mix versus warm mix.

The photo on the left is hot mix, and after being rolled the edge shape has some minor roll up on the top of the safety edge shape. This may result in a finished angle greater than 30 degrees. The finished angle was closer to 40 degrees.

The photo on the right is warm mix, and after being rolled the edge appears to flatten out (as shown in the previous slide). This may result in a finished angle less than 30 degrees. The finished angle was closer to 26 degrees.

In January 2012, FHWA released new specifications where the finished safety edge product is acceptable between 26 and 40 degrees.

Left - Photo from March 21, 2011. Map 5 – SR 1354 (1.61 miles). 1.5" Lift, Hot Mix. Shoe – NCDOT Prototype 1.

Right - Photo from March 24, 2011. Map 2 – SR 1921 (0.64 miles). 1.5" Lift, Warm Mix. Shoe – NCDOT Prototype 1.

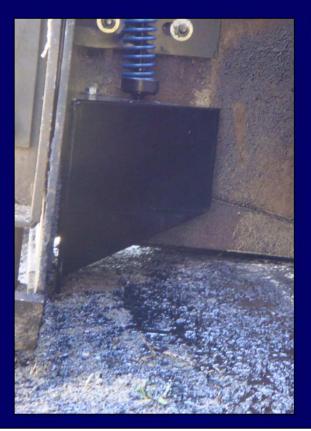
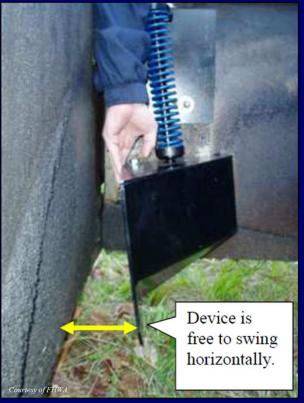
• Internal Device – Be Aware of Horizontal Float

This slide demonstrates the 30 degree shaped edge maker (Troxler (very similar to Trans-Tech)) in photo on the left. The photo on the right demonstrates the edge makers potential to rotate out from the end gate, resulting in a safety edge form that could be from 30 to 50 degrees.

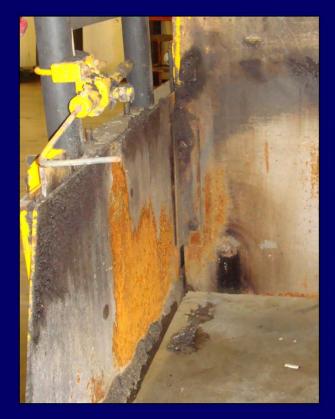
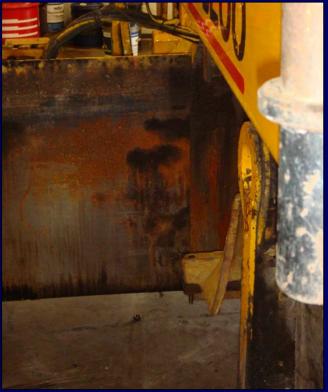
Internal Device – Did Not Work on this Screed

This slide demonstrates that the internal safety edge devices would not fit on this machine due to the bolt placement and metal bracing on the end gate. Also, this is a 10' paver and would have the same problems with paving lanes less than 12' due to the Auger placement if a internal shoe could be developed to fit.

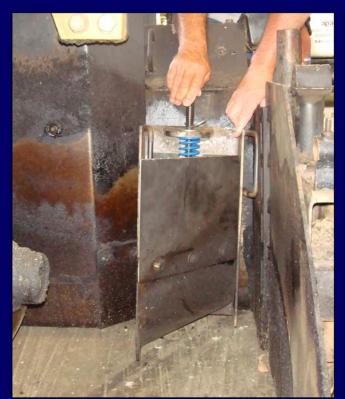
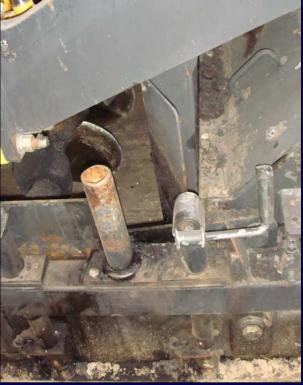
Internal Device – Did Not Work on this Screed

This slide demonstrates that the internal safety edge devices would not fit on this machine due to the rear kick plate. Also, this is a 10' paver and would have the same problems with paving lanes less than 12' due to the rear kick plate.

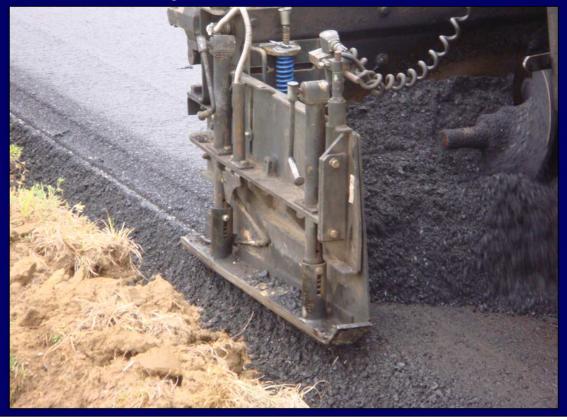
Harnett County – SR 2215

The toe of the wedge was placed at the edge of the new sub pavement.

Photos from April 11, 2011. SR 2215 (1.97 miles). 1.5" Lift, Warm Mix. Shoe – NCDOT Prototype 2.

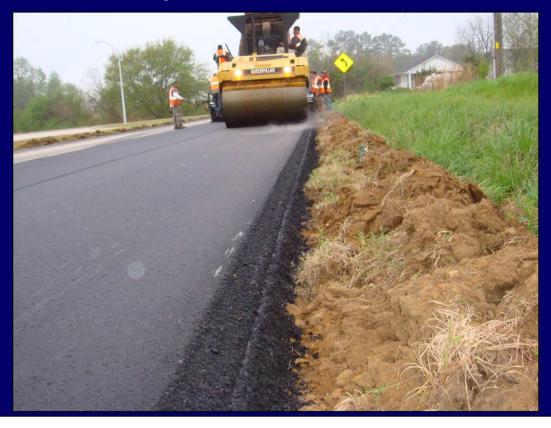
Harnett County – SR 2215

The toe of the wedge was placed at the edge of the new sub pavement.

Photos from April 11, 2011. SR 2215 (1.97 miles). 1.5" Lift, Warm Mix. Shoe – NCDOT Prototype 2.

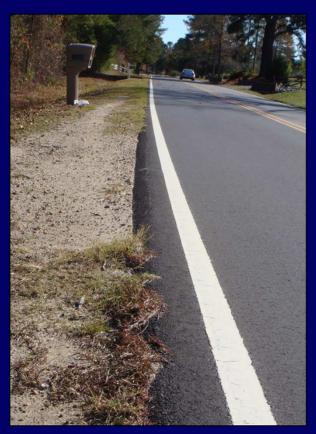
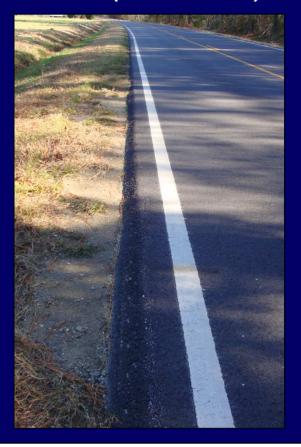
Hot Mix Installation – SR 1938 (6 months)

These photos are the 6 month after observation.

Photo from November 18, 2011. Map 1-SR 1938 (1.89 miles). 1.5" Lift, Hot Mix. Shoe – Carlson End Gate.

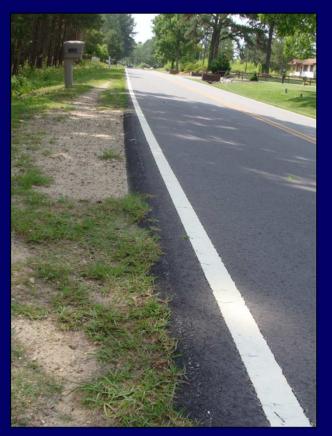
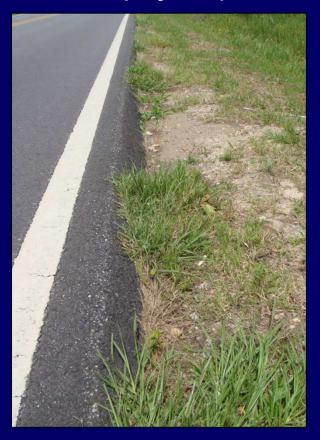
Hot Mix Installation – SR 1938 (1 year)

These photos are the 1 year after observation.

Photo from May 17, 2012. Map 1 – SR 1938 (1.89 miles). 1.5" Lift, Hot Mix. Shoe – Carlson End Gate.

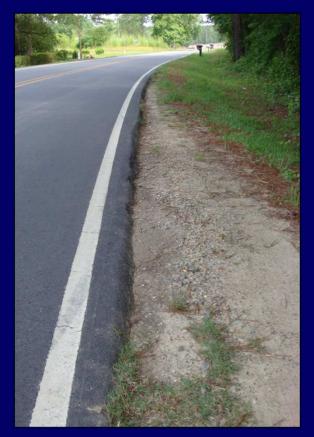
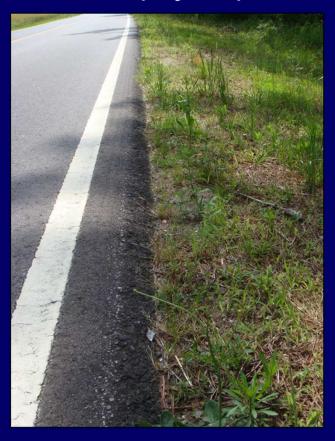
Hot Mix Installation – SR 1938 (1 year)

These photos are the 1 year after observation.

Photo from May 17, 2012. Map 1 – SR 1938 (1.89 miles). 1.5" Lift, Hot Mix. Shoe – Carlson End Gate.

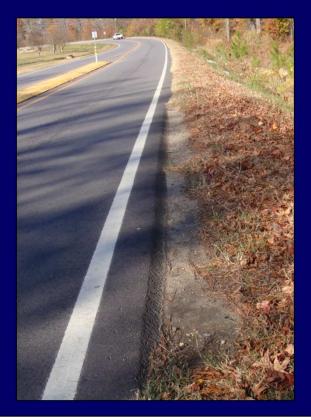
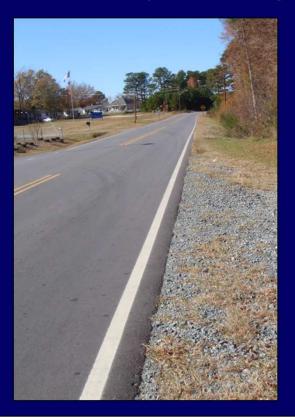
Warm Mix Installation – SR 1921 (6 months)

Photo from November 18, 2011. Map 2-SR 1921 (0.64 miles). 1.5" Lift, Warm Mix. Shoe -NCDOT Prototype 1.

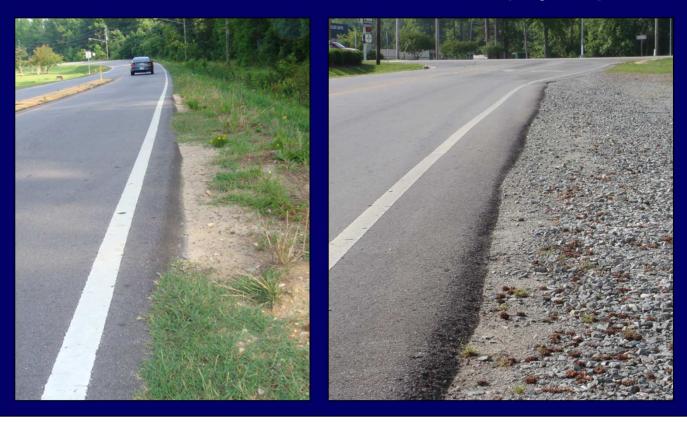
Warm Mix Installation – SR 1921 (1 year)

Photo from May 17, 2012. Map 2 – SR 1921 (0.64 miles). 1.5" Lift, Warm Mix. Shoe – NCDOT Prototype 1.

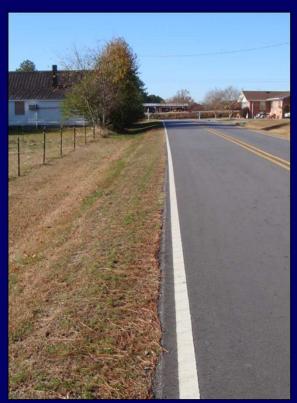
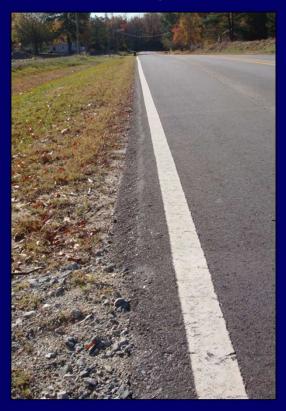
• Warm Mix Installation – SR 1327 (6 months)

Photo from November 18, 2011. Map 3 – SR 1327 (0.94 miles). 1.5" Lift, Warm Mix. Shoe – NCDOT Prototype 1.

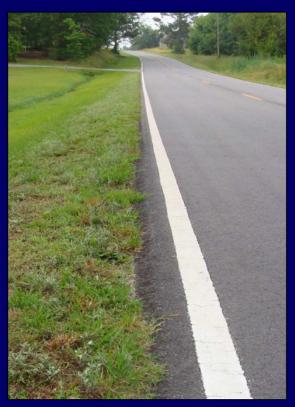
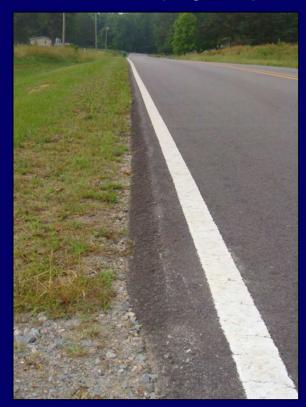
Warm Mix Installation – SR 1327 (1 year)

Photo from May 17, 2012. Map 3 – SR 1327 (0.94 miles). 1.5" Lift, Warm Mix. Shoe – NCDOT Prototype 1.

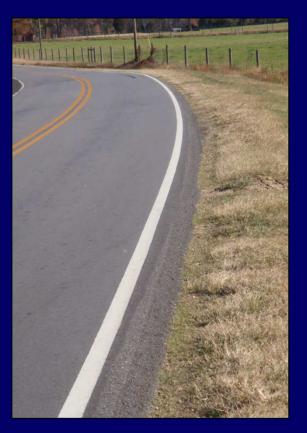
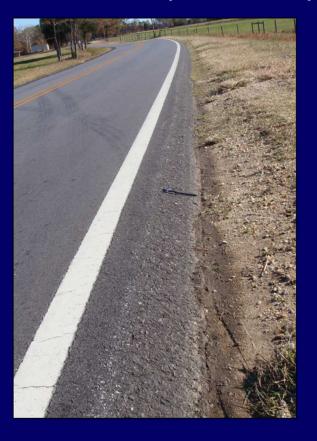
Warm Mix Installation – SR 1007 (6 months)

These photos are the 6 month after observation. Notice the pen in the photo on the right, the safety edge shape is fully exposed.

Photo from November 18, 2011. Map 4-SR 1007 (2.10 miles). 1.5" Lift, Warm Mix. Shoe – NCDOT Prototype 2.

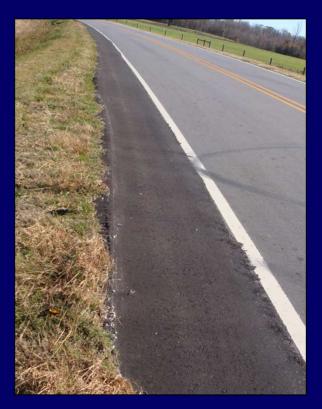
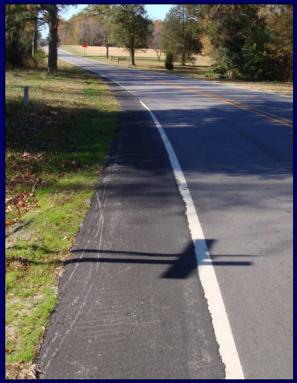
Warm Mix Installation – SR 1007 (6 months)

Photo from November 18, 2011. Map 4-SR 1007 (2.10 miles). 1.5" Lift, Warm Mix. Shoe – NCDOT Prototype 2.

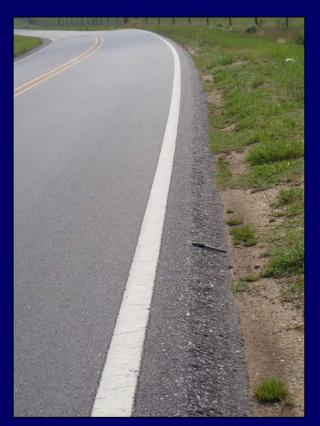
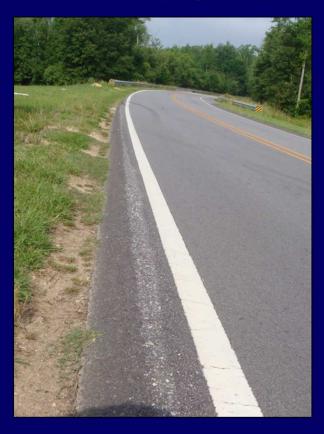
Warm Mix Installation – SR 1007 (1 year)

These photos are the 1 year after observation. Notice the pen in the photo on the right, the safety edge shape is fully exposed.

Photo from May 17, 2012. Map 4 – SR 1007 (2.10 miles). 1.5" Lift, Warm Mix. Shoe – NCDOT Prototype 2.

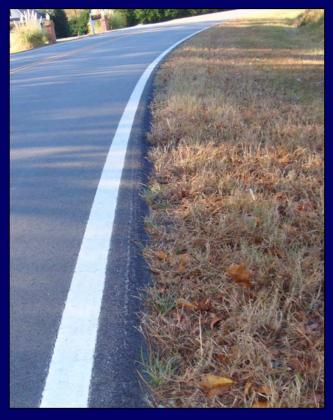
Hot Mix Installation – SR 1355 (6 months)

These photos are the 6 month after observation. Notice the pen in the photo on the right, the safety edge shape is fully exposed.

Photo from November 18, 2011. SR 1355. 1.5" Lift, Hot Mix. Shoe – NCDOT Prototype 2.

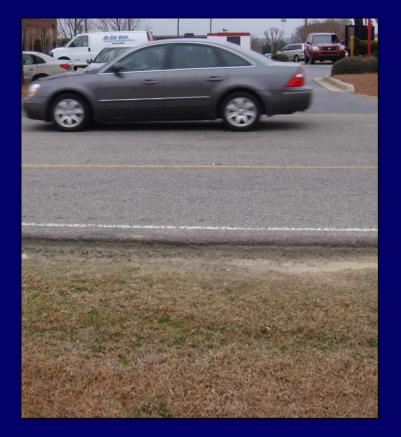
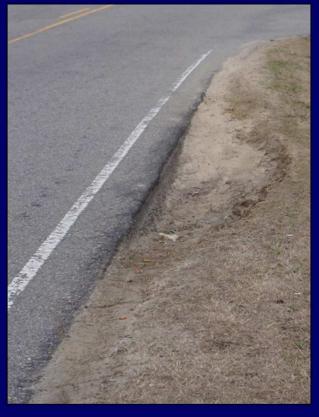
Warm Mix Installation – SR 1547 (before)

These photos are the before observation.

Photo from March 2011. SR 1547. 1.5" Lift, Warm Mix. Shoe – NCDOT Prototype 2.

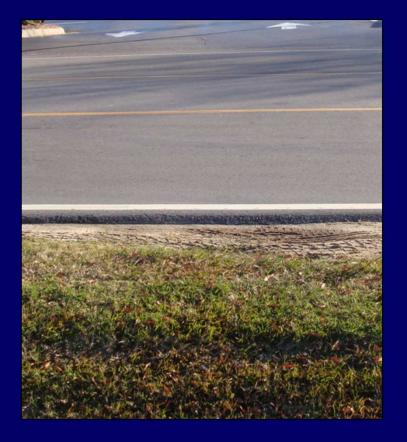
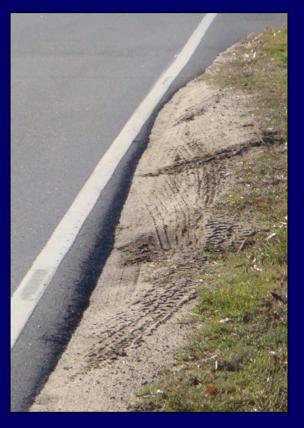
• Warm Mix Installation – SR 1547 (6 months)

These photos are the 6 month after observation.

Photo from November 18, 2011. SR 1547. 1.5" Lift, Warm Mix. Shoe – NCDOT Prototype 2.

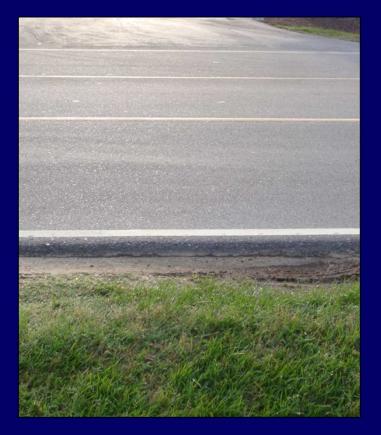
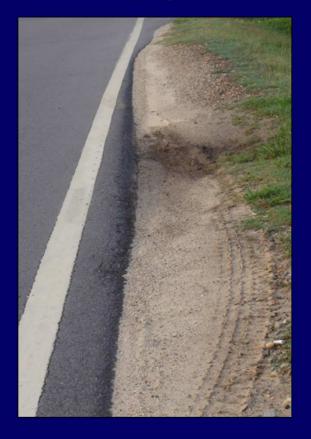
• Warm Mix Installation – SR 1547 (1 year)

These photos are the 1 year after observation.

Photo from May 17, 2012. SR 1547. 1.5" Lift, Warm Mix. Shoe – NCDOT Prototype 2.

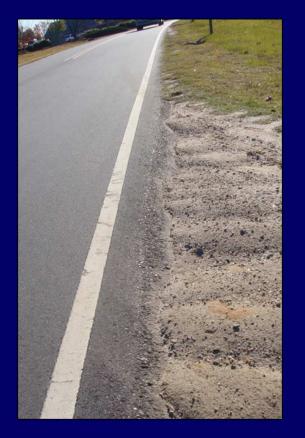
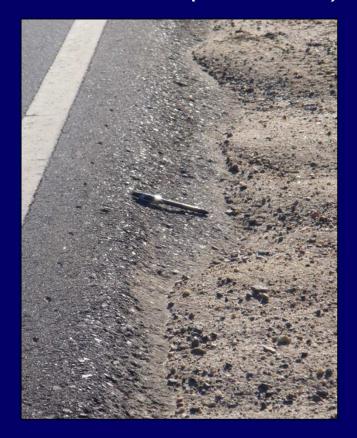
Warm Mix Installation – SR 1547 (6 months)

These photos are the 6 month after observation.

Photo from November 18, 2011. SR 1547. 1.5" Lift, Warm Mix. Shoe – NCDOT Prototype 2.

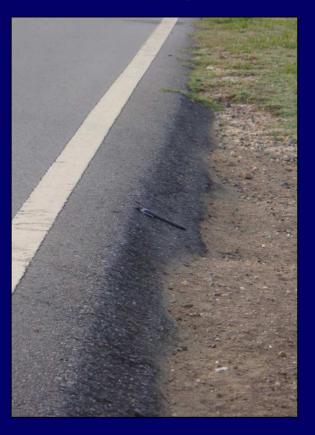
• Warm Mix Installation – SR 1547 (1 year)

These photos are the 1 year after observation. Notice the pen in the photo on the right, the safety edge shape is fully exposed.

Photo from May 17, 2012. SR 1547. 1.5" Lift, Warm Mix. Shoe – NCDOT Prototype 2.

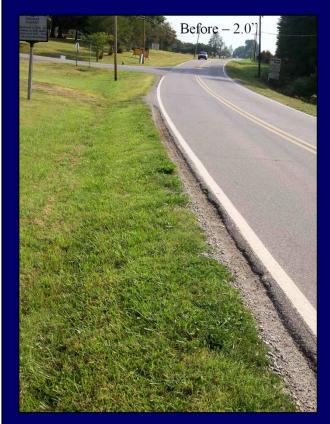
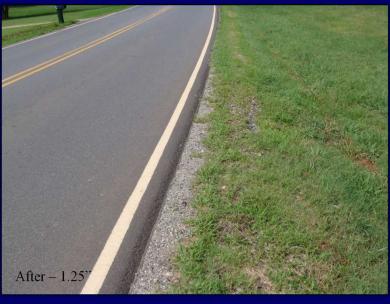
Observation Site A (-0.5 years and 1.5 years)

Left side is before (2.0 inch drop-off), right side is after 1 (1.25 inch drop-off). This site re-rutted in the after 1 period. Notice that edge is exposed in the after period and appears to be holding up to traffic.

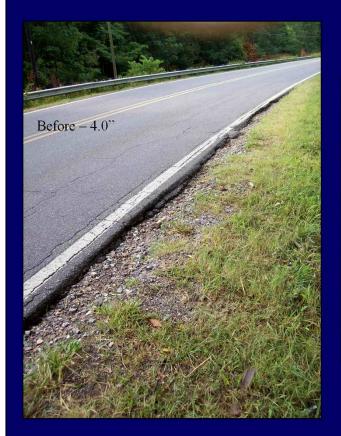
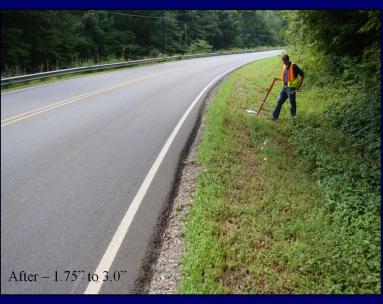
Observation Site B (-0.5 years and 1.5 years)

Left side is before (4.0 inch drop-off), right side is after 1 (1.75 to 3.0 inch drop-off). This site re-rutted in the after 1 period. Notice that edge is exposed in the after period and appears to be holding up to traffic.

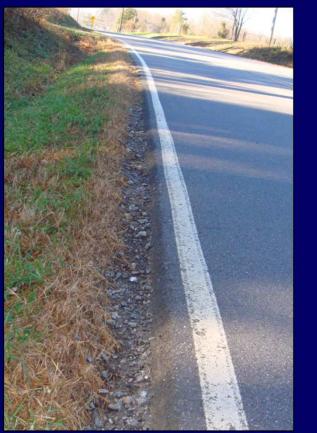
• Observation Site C (3.0 years)

This site DID NOT re-rut in the first after 1 period but DID rut over the next 1.5 years in the after 2 period.
